TV mount hazard example

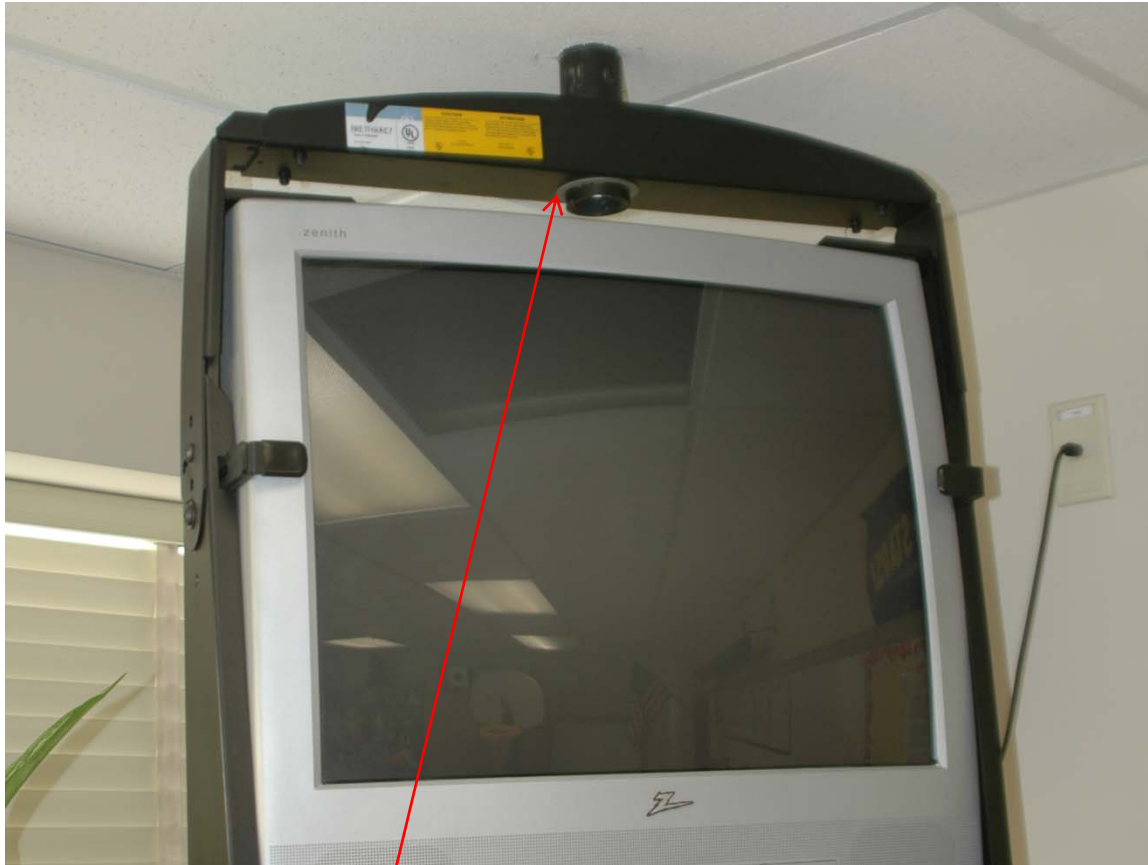
Note the flange

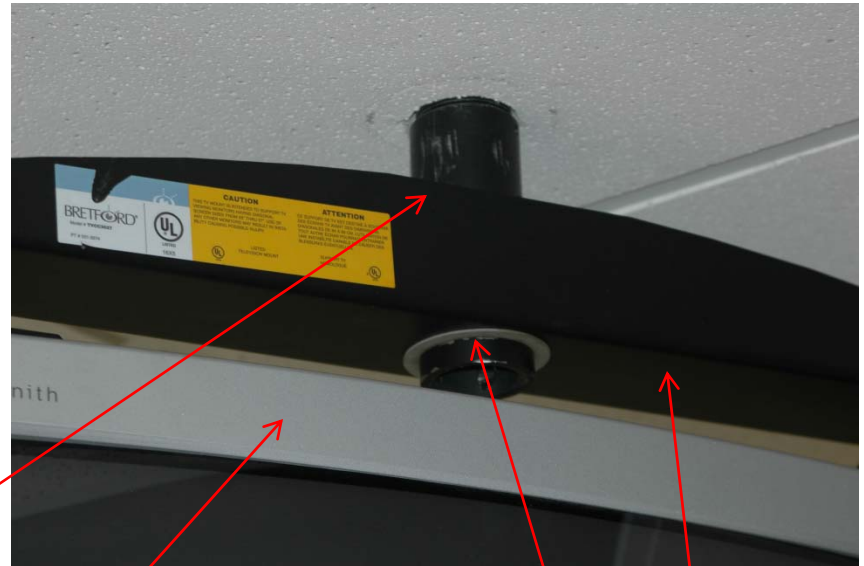
Mounting description

Note the Flange. The TV is attached to a mount system. The flange is screwed onto the pipe. The flanges keep the mount at a certain level and act as the attachment device to the pipe that comes down from the ceiling. This pipe is part of the apparatus.

Pipe

TV

Lower flange

Mount

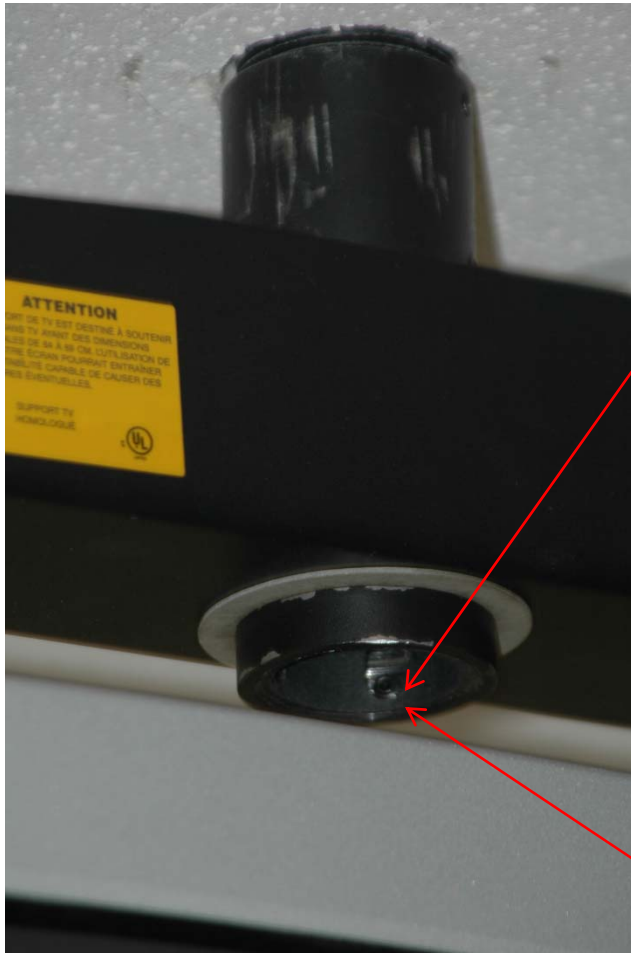
Proper installation

Note the set screw. The set screw keeps the flange from coming loose/unscrewing from the pipe. The set screw should go through a slot in the side of the flange. This photo shows this set up.

The slot shows up on the photo as a shiny area. It has a U shape

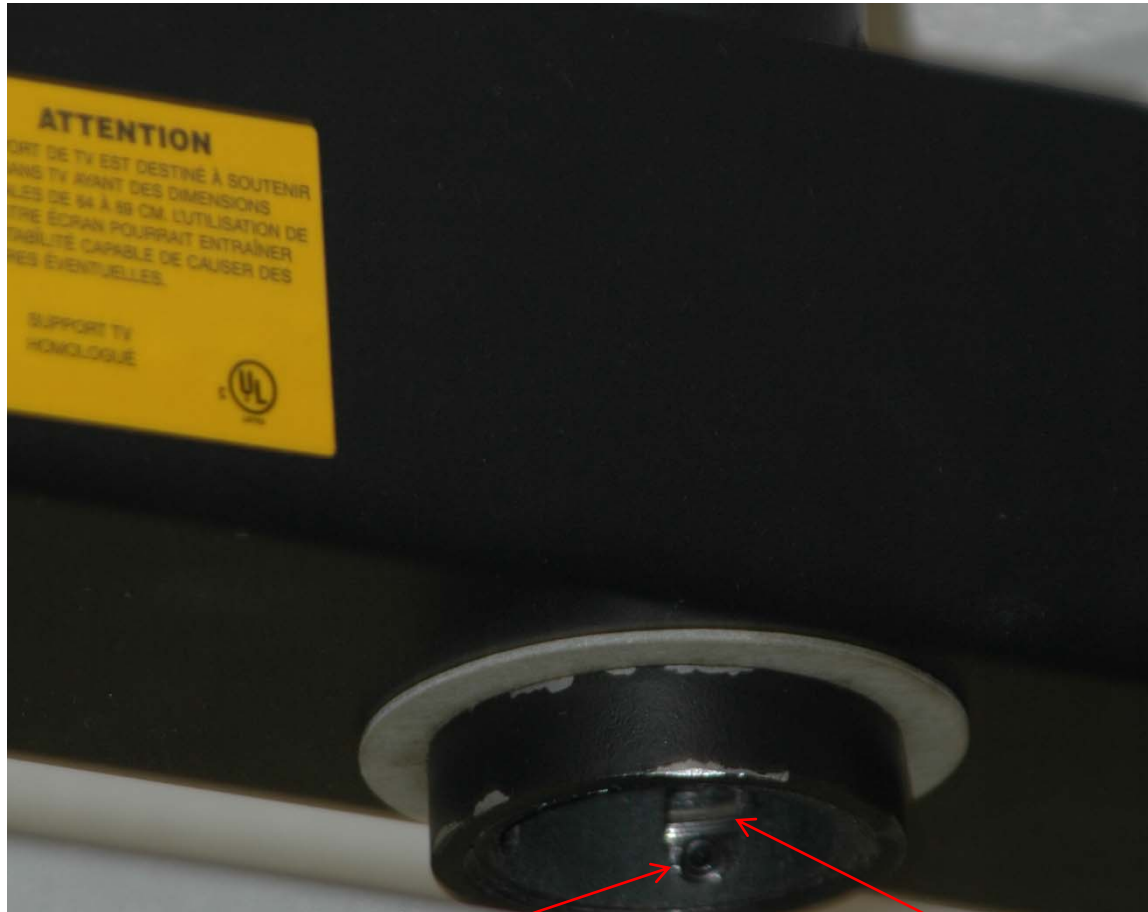
Note set screw

Note the knockout

Set screw is set into the knockout. This is the correct installation.

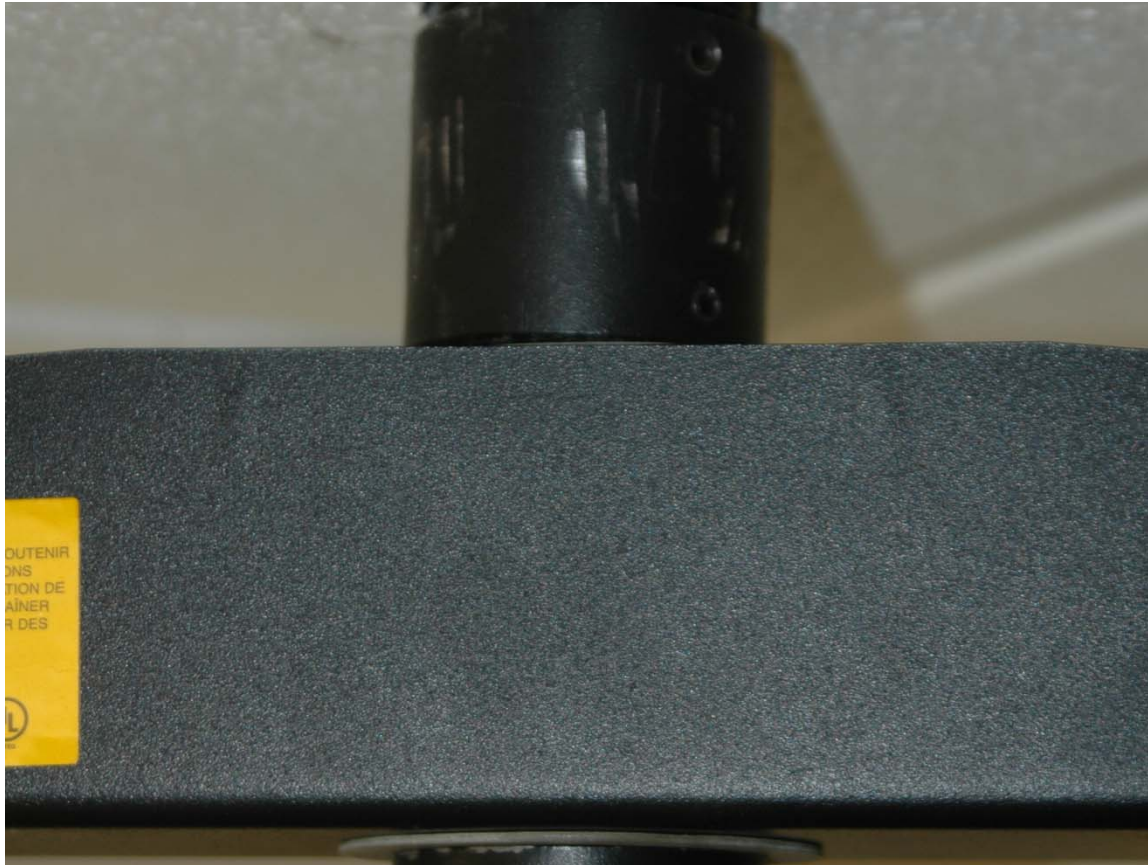
Flange on the top of the mount system

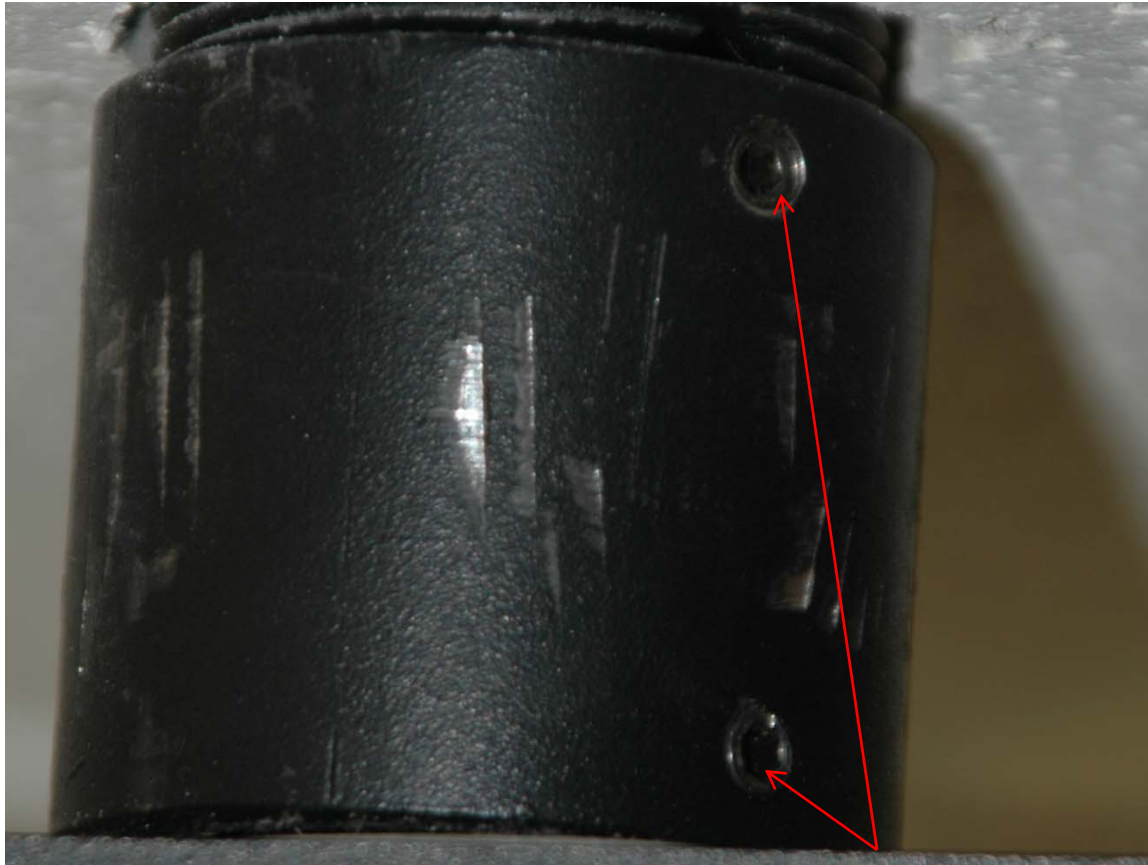
Flange on top of the TV mount – note set screws are into the mount

The scratches are not an issue in this discussion

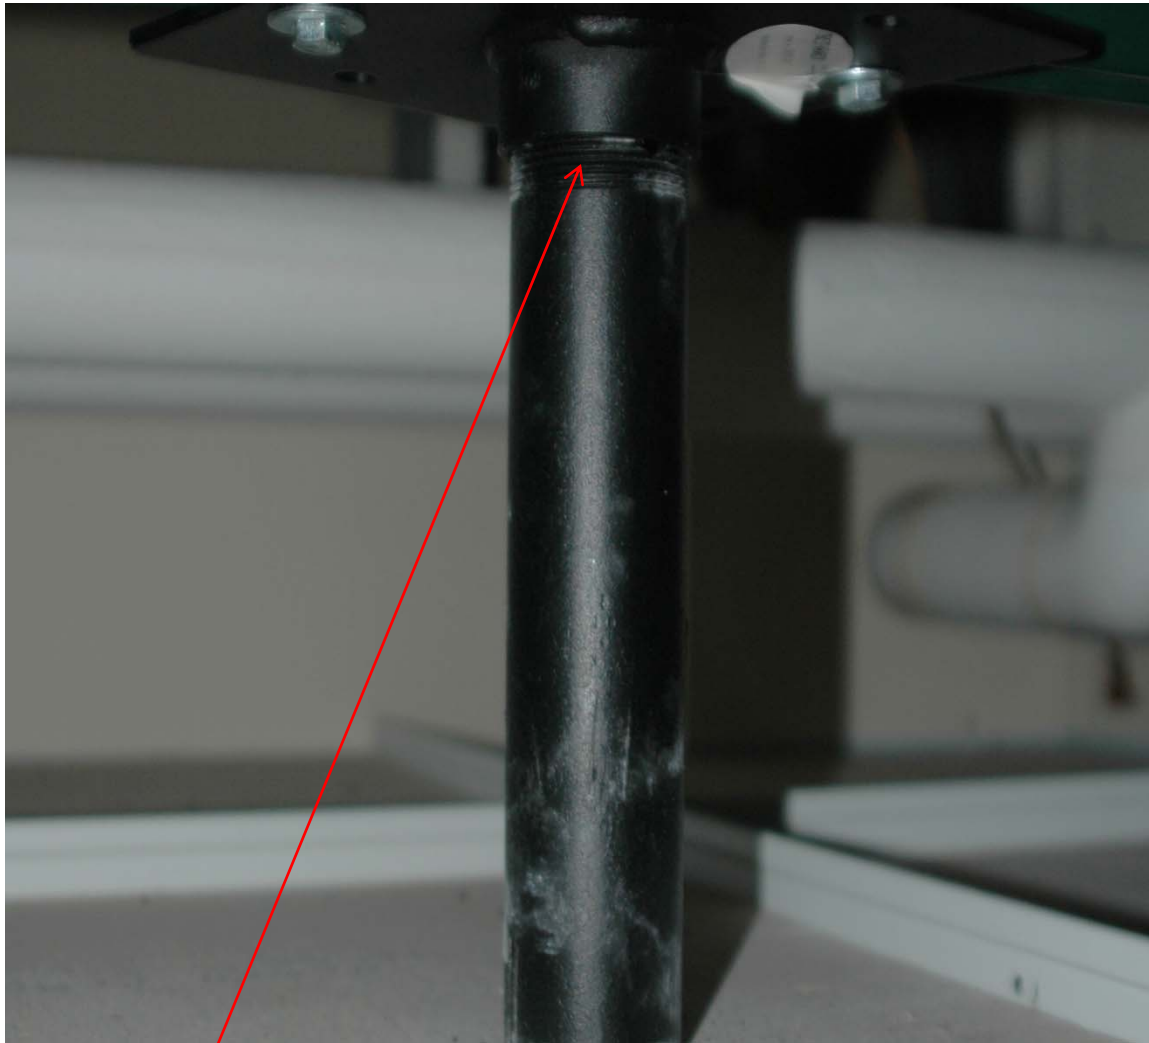
Mounting system in the ceiling - flange system is used. Note threads on the pipe

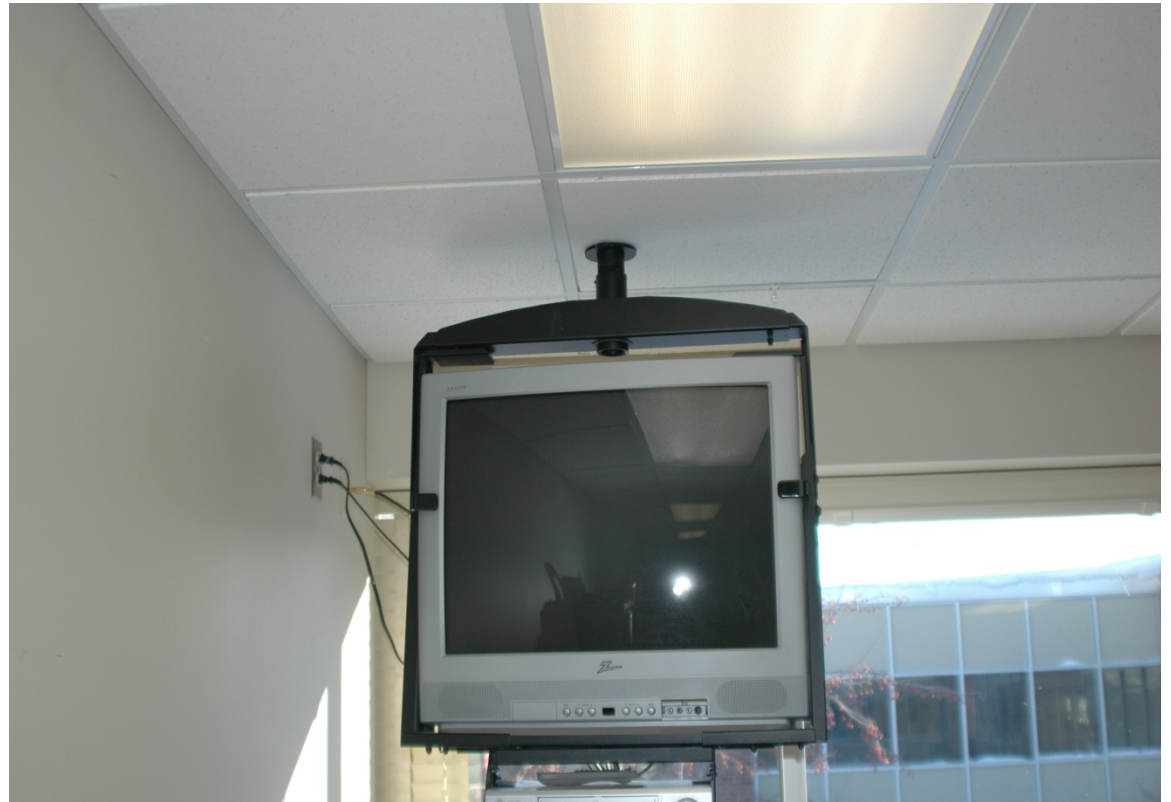
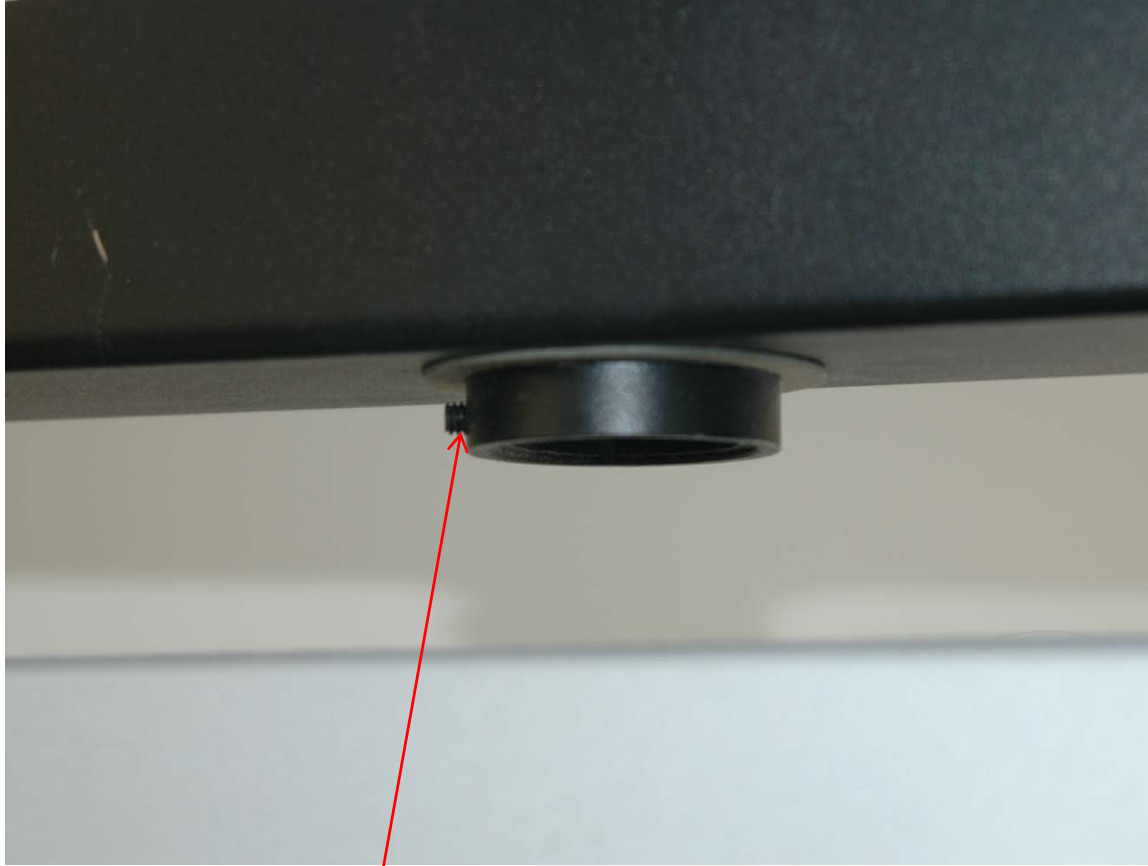
TV mount with incorrect installation

Bottom flange – note the set screw is sticking out, indicating the screw is not in the slot of the flange. The screw goes up against the flange rather into the slot

It appears that the TV mount system was not installed properly. The set screw was not in the slot of the flange.

As the TV was used since the summer of 2002, the flange started to unscrew from the pipe because the set screw was not positioned in the slot.

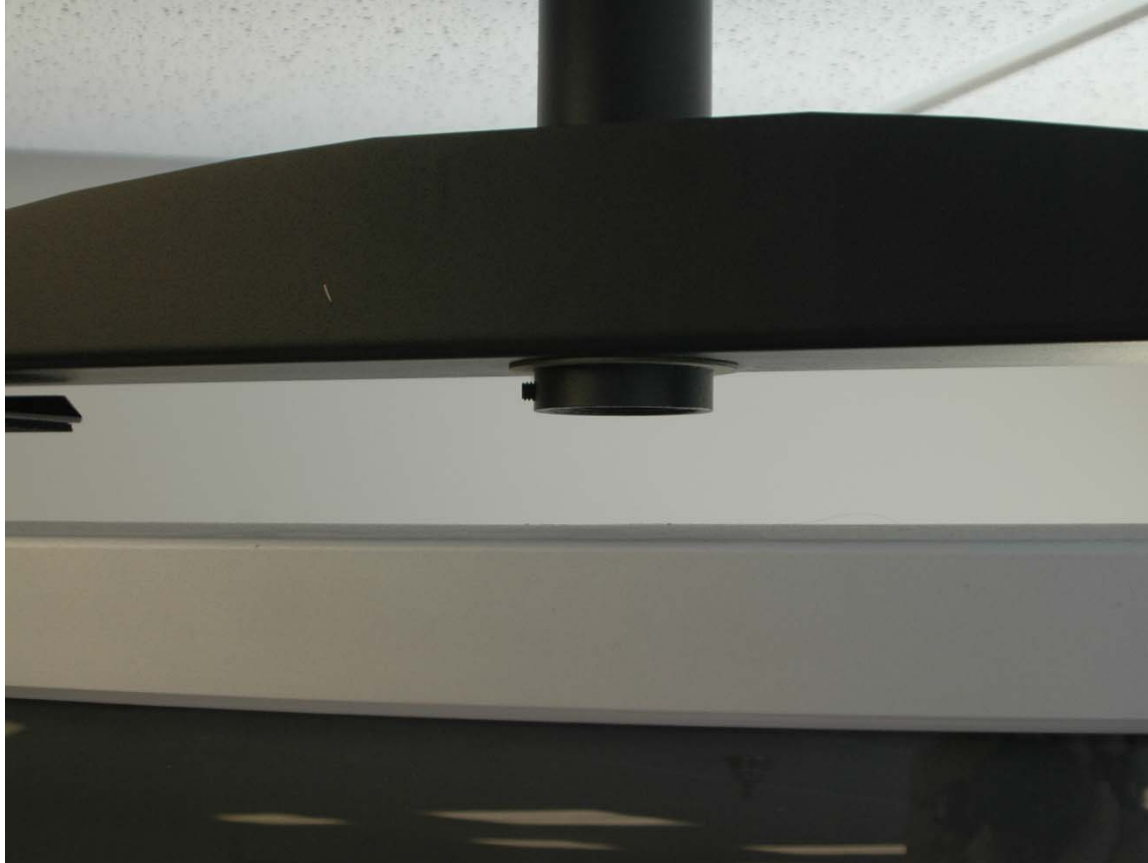
Bottom flange – incorrect installation

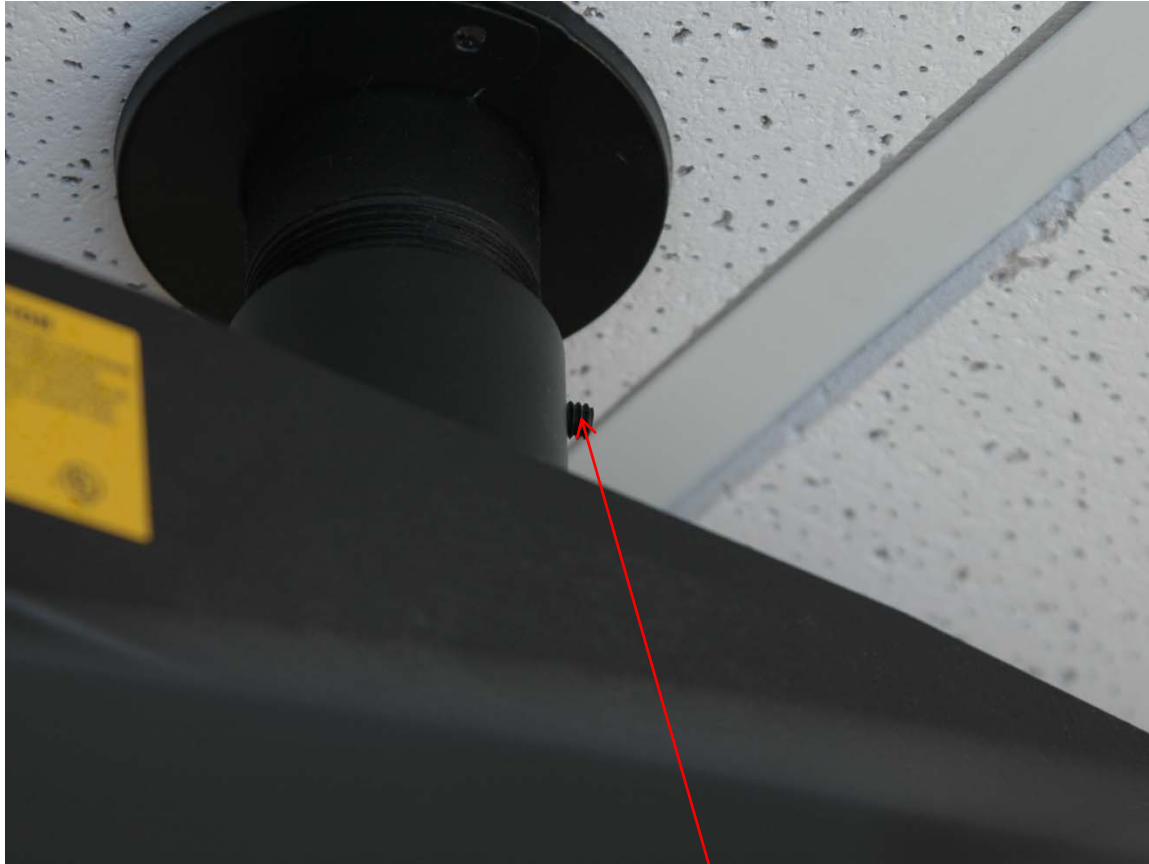
Top flange –Set screw is sticking out. Incorrect installation.
